Evaluation of Thermoplastic Marking Materials

May 2008

DOT/FAA/AR-TN08/22

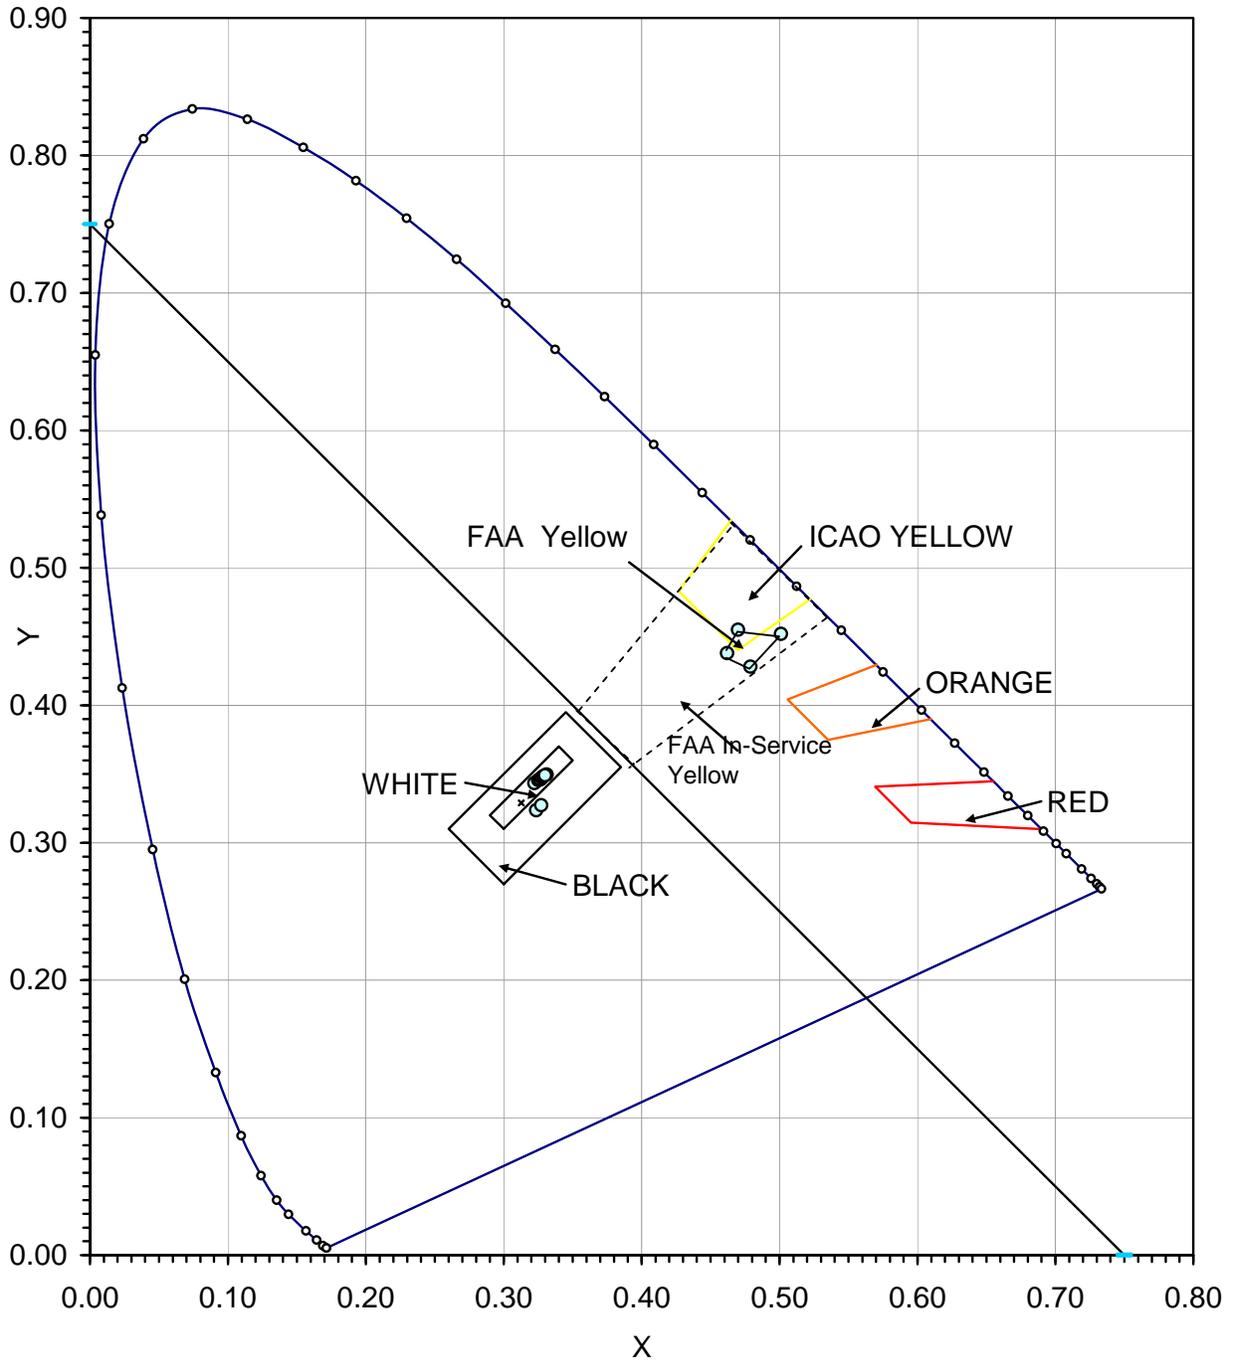
Figure A-35. Chromaticity Readings of CCWS-2, 3-Foot Stripe (White) at FAA William J. Hughes Technical Center

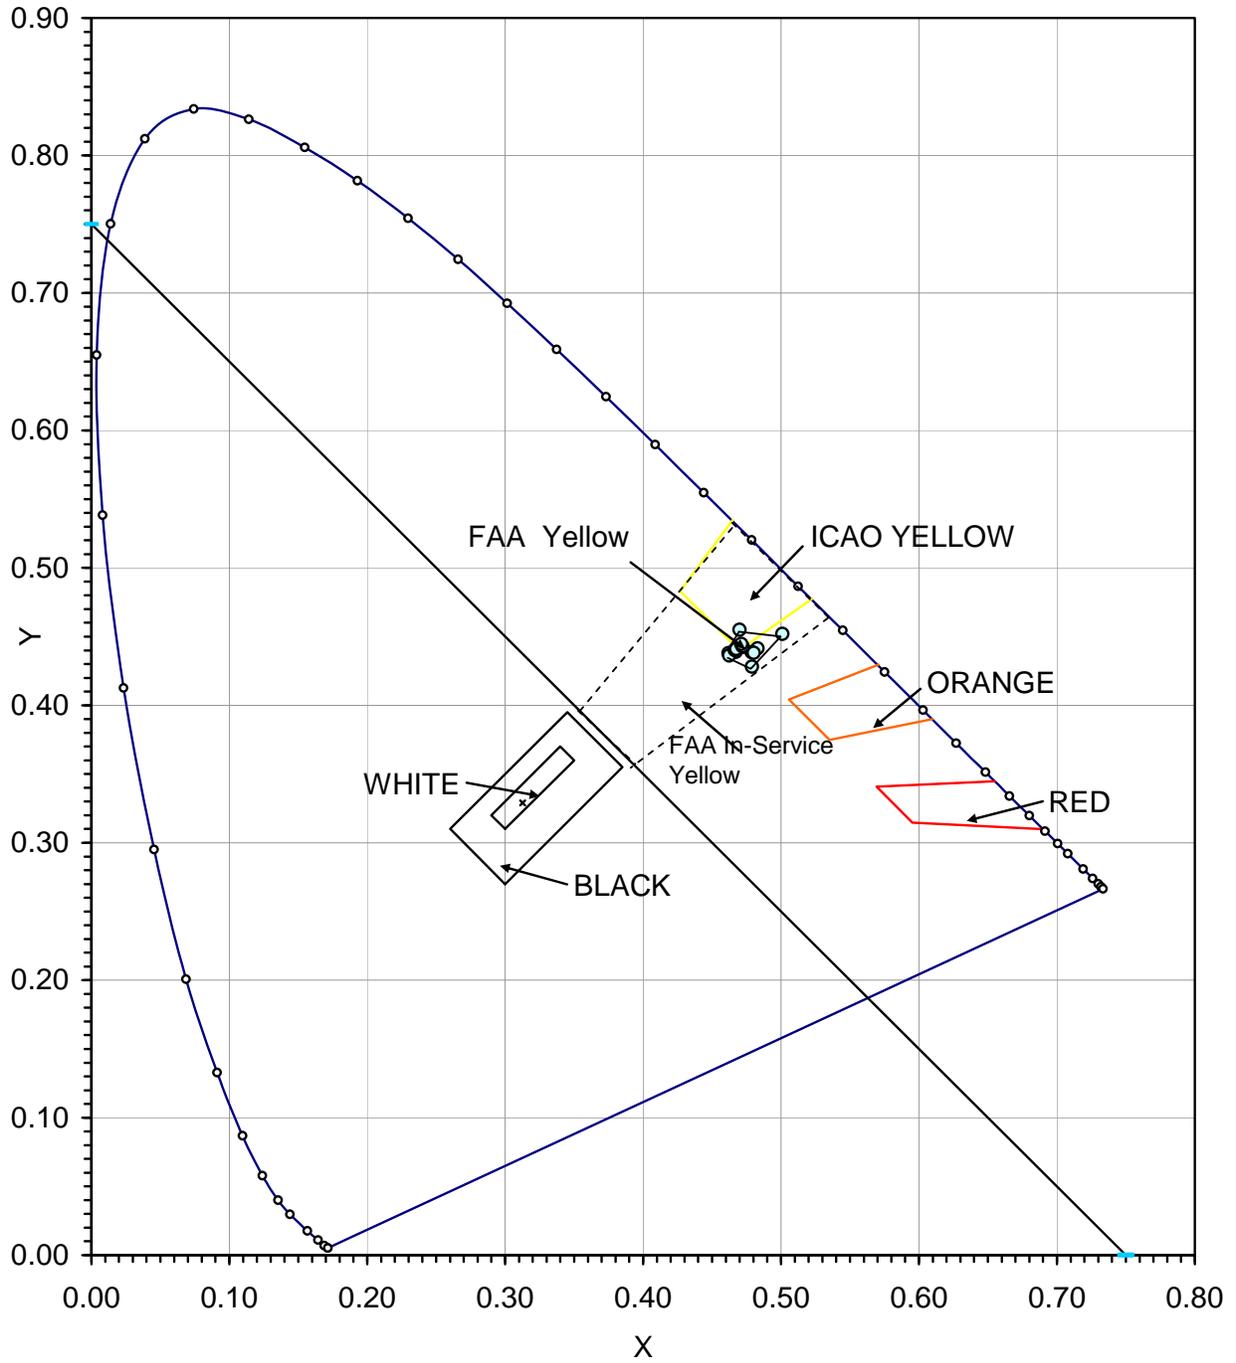
Figure A-36. Chromaticity Readings of CCYS-2, 3-Foot Stripe (Yellow) at FAA William J. Hughes Technical Center

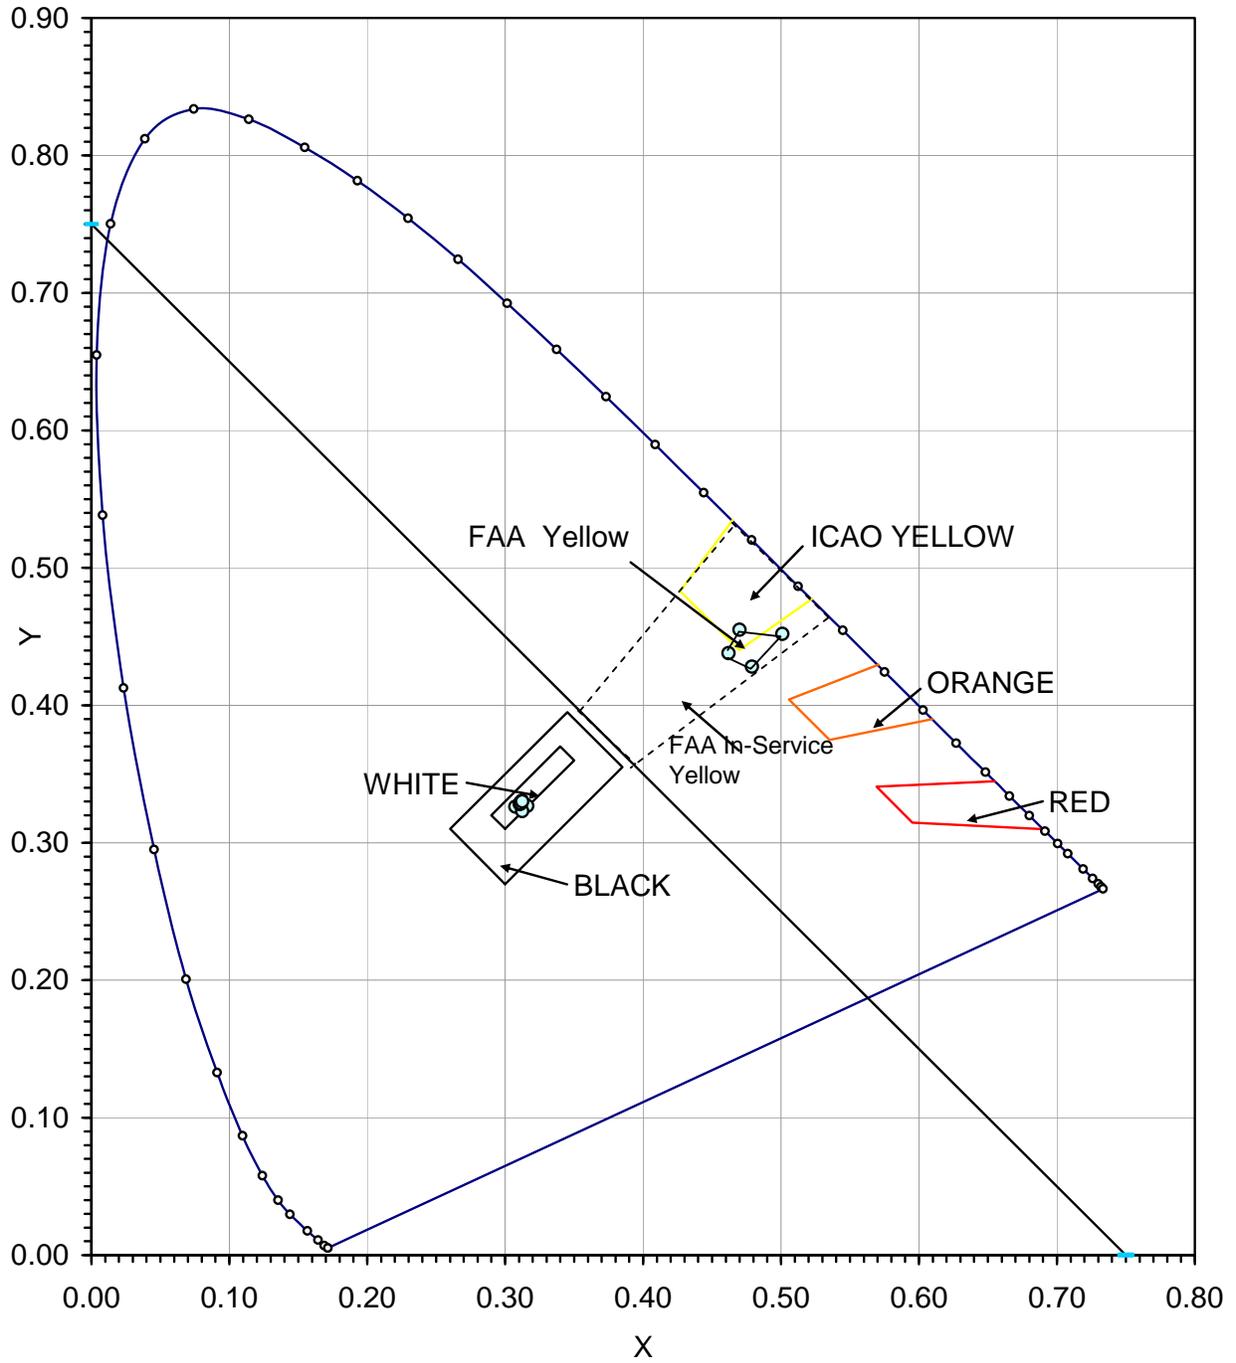
Figure A-37. Chromaticity Readings of CCBS-2, 3-Foot Stripe (Black) at FAA William J. Hughes Technical Center

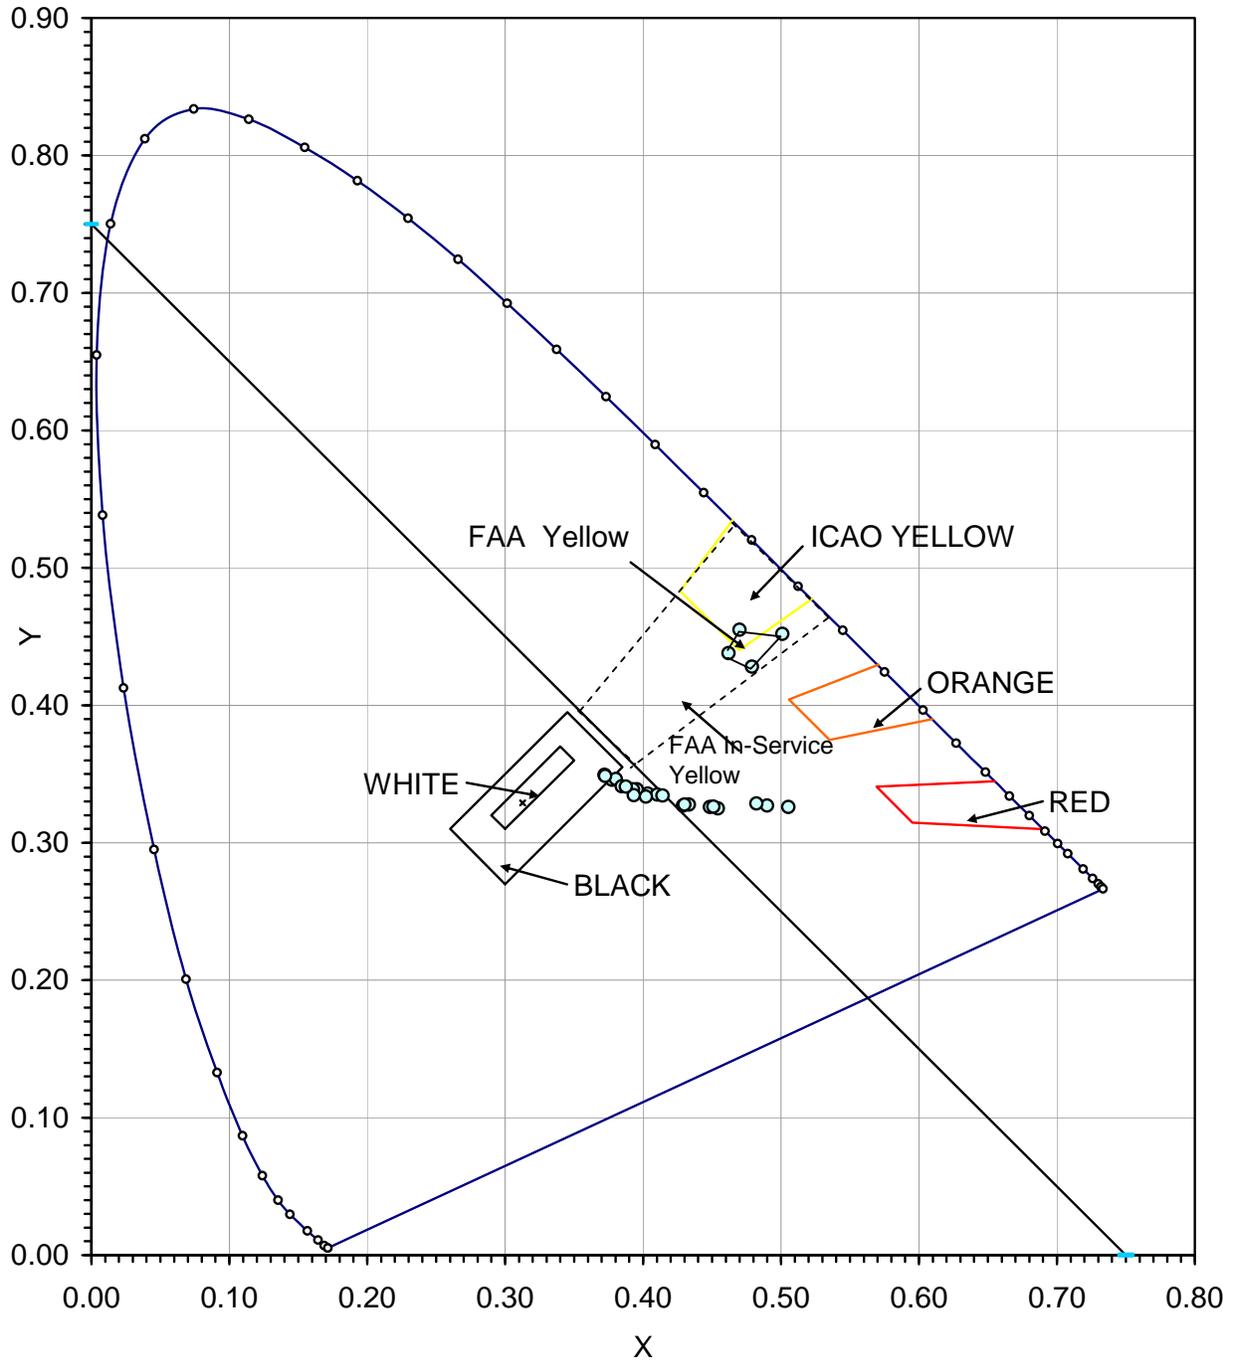
Figure A-38. Chromaticity Readings of HMRS-2, 3-Foot Stripe (Red) at FAA William J. Hughes Technical Center

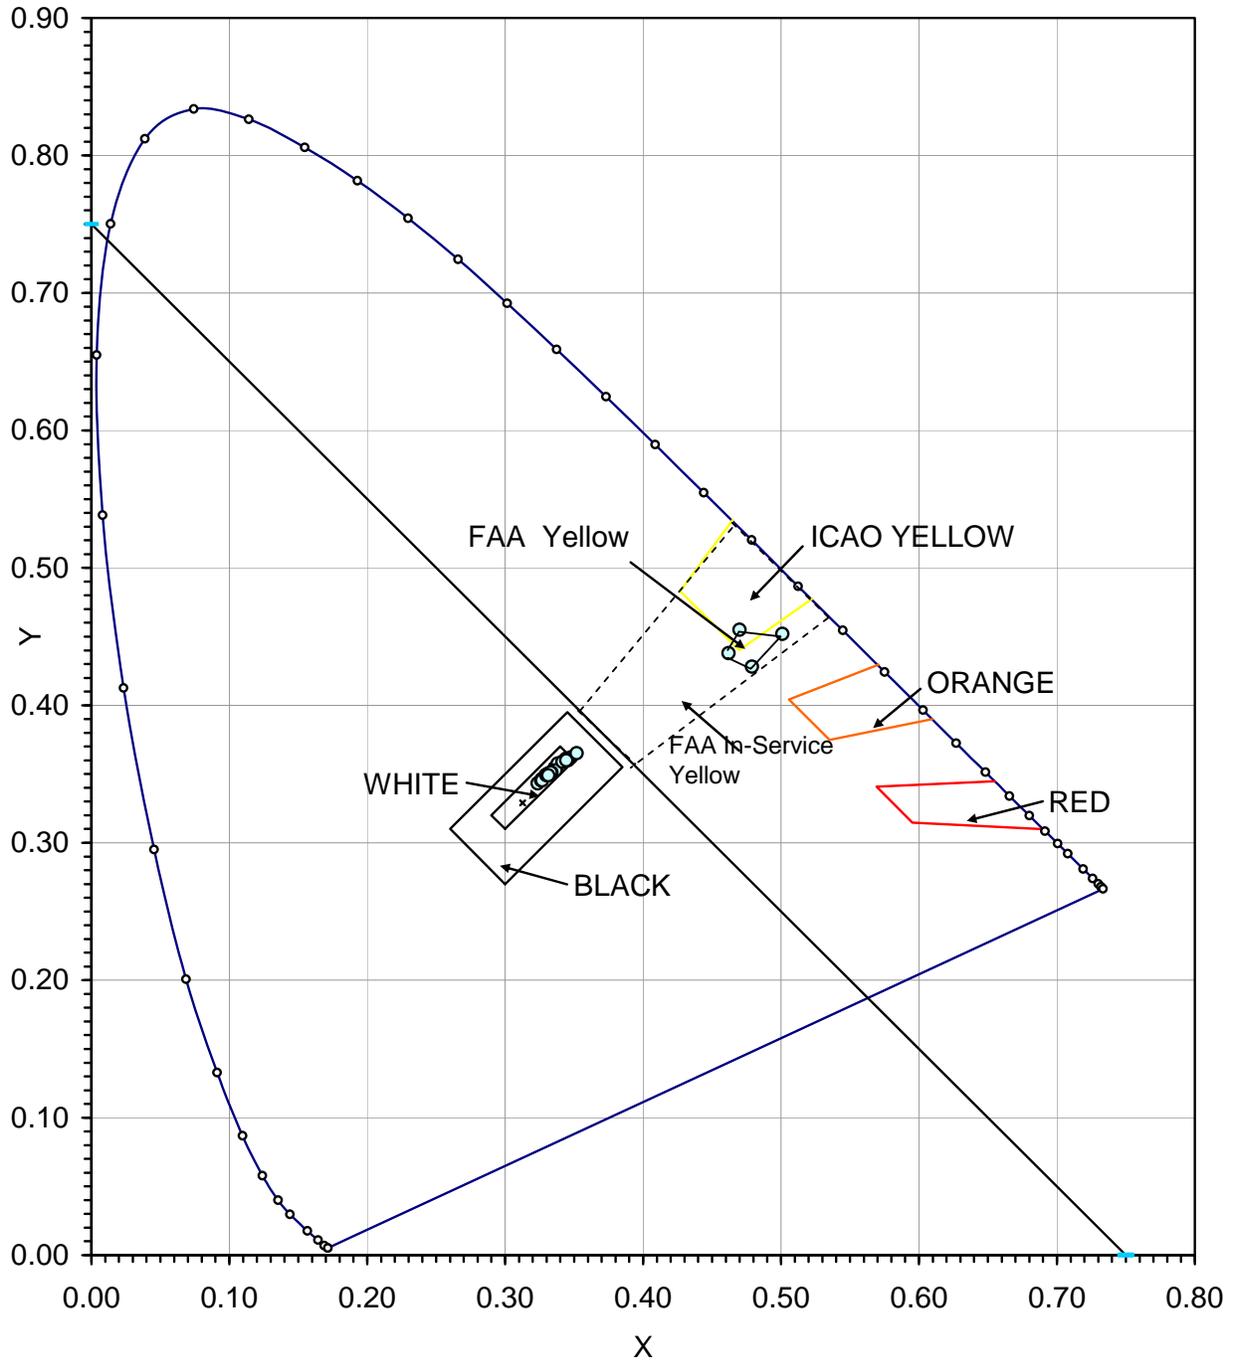
Figure A-39. Chromaticity Readings of HMWS-2, 3-Foot Stripe (White) at FAA William J. Hughes Technical Center

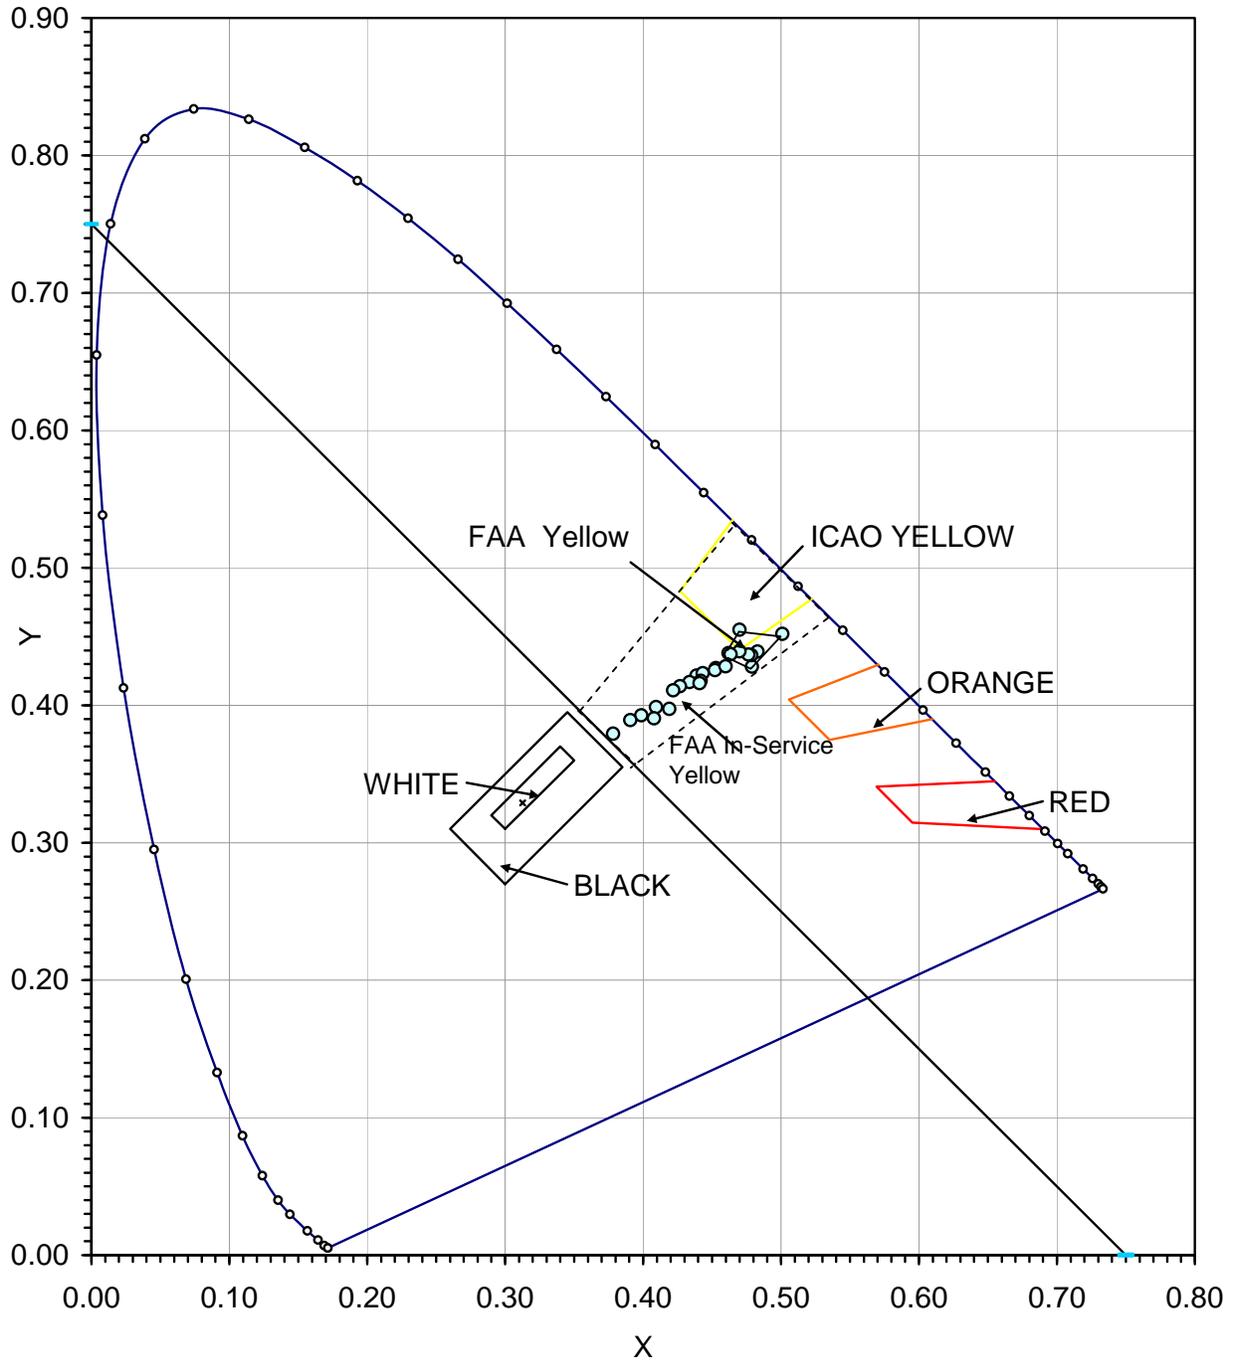
Figure A-40. Chromaticity Readings of HMYS-2, 3-Foot Stripe (Yellow) at FAA William J. Hughes Technical Center

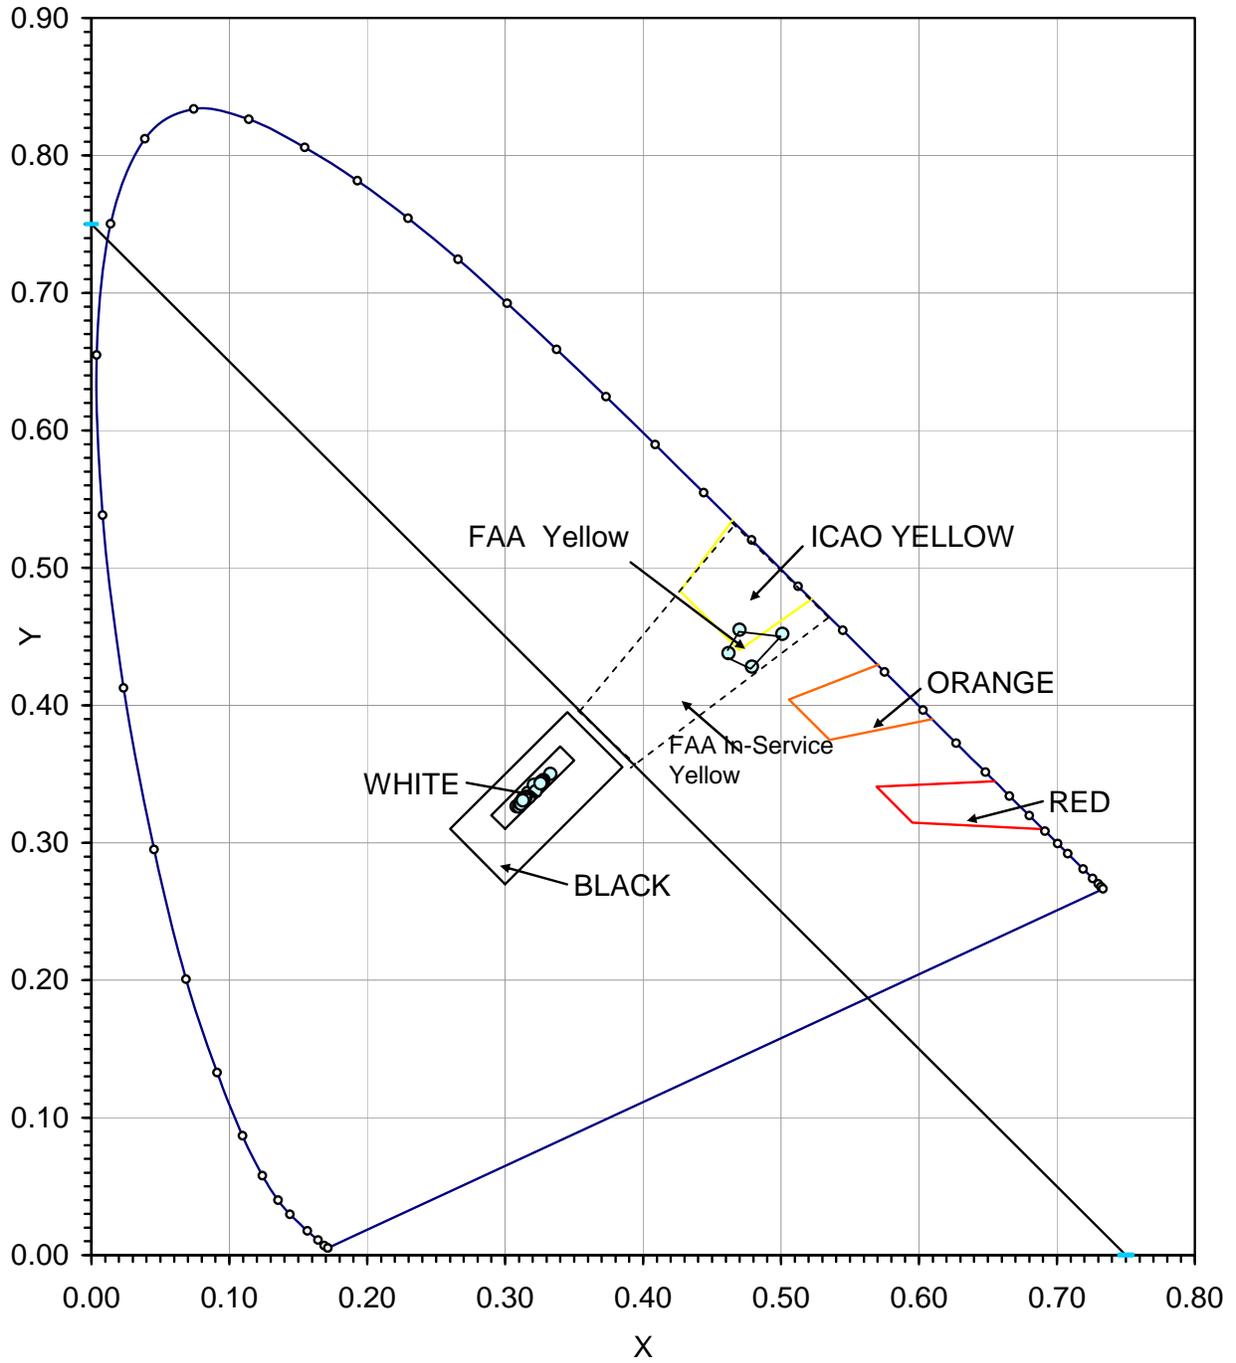
Figure A-41. Chromaticity Readings of HMBS-2, 3-Foot Stripe (Black) at FAA William J. Hughes Technical Center

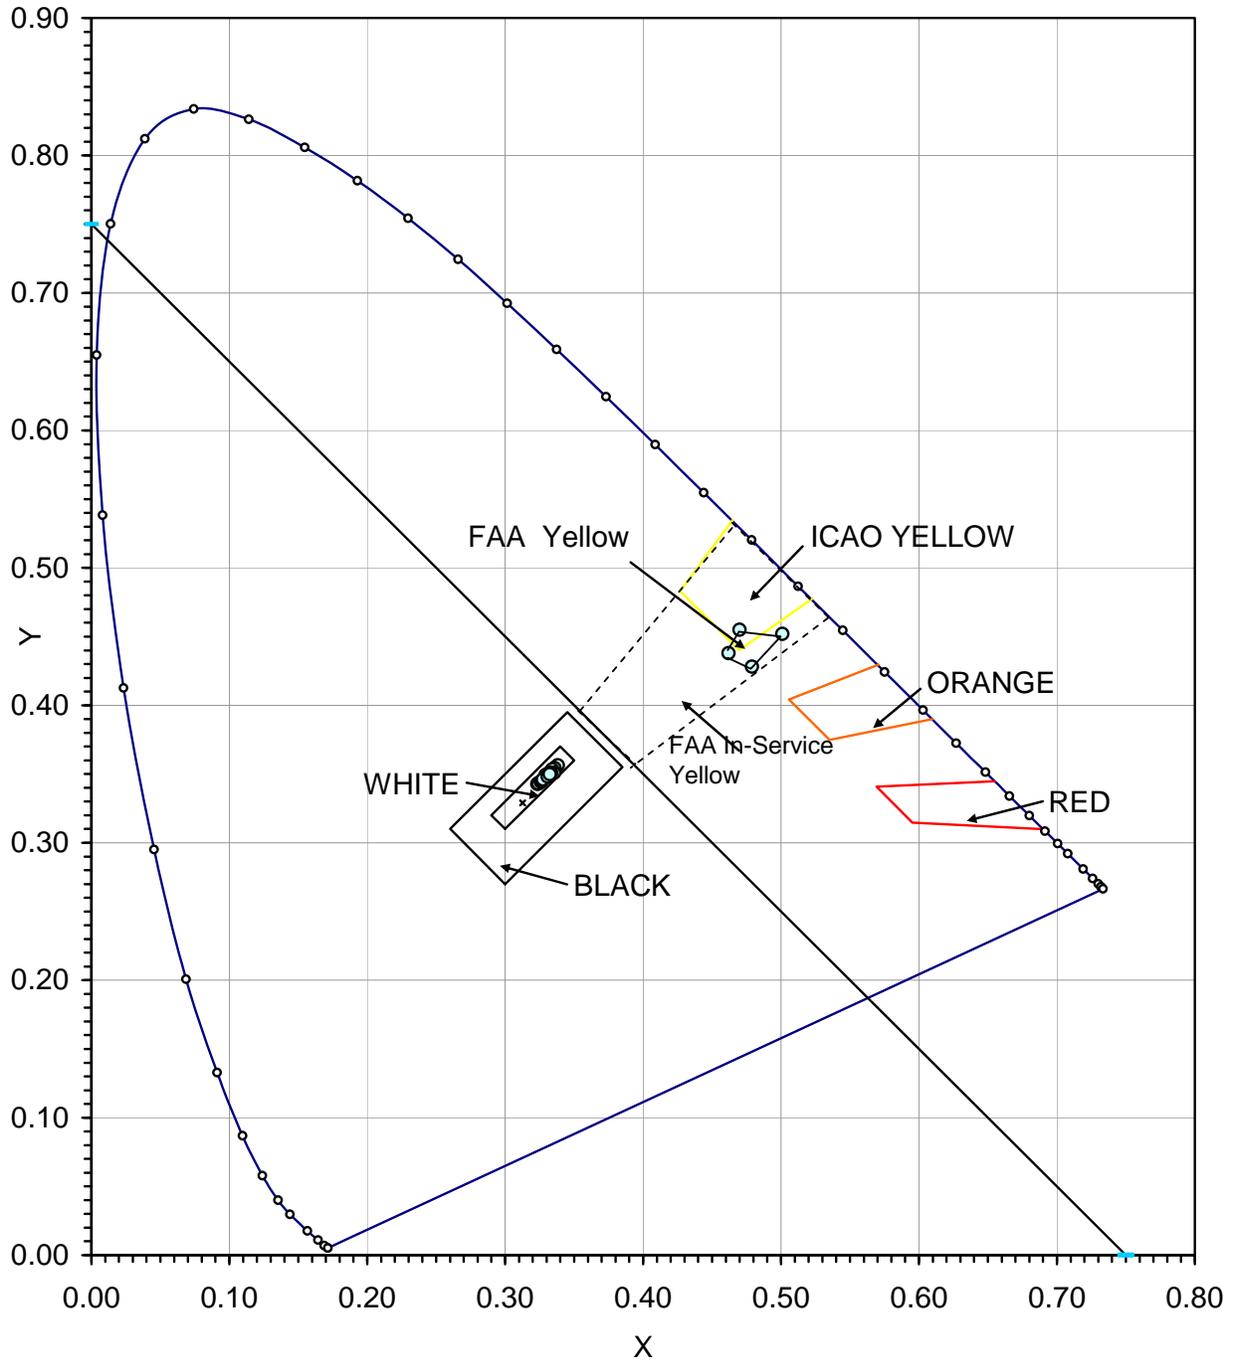
Figure A-42. Chromaticity Readings of HMWSL-2, 150-Foot Stripe (White) at FAA William J. Hughes Technical Center

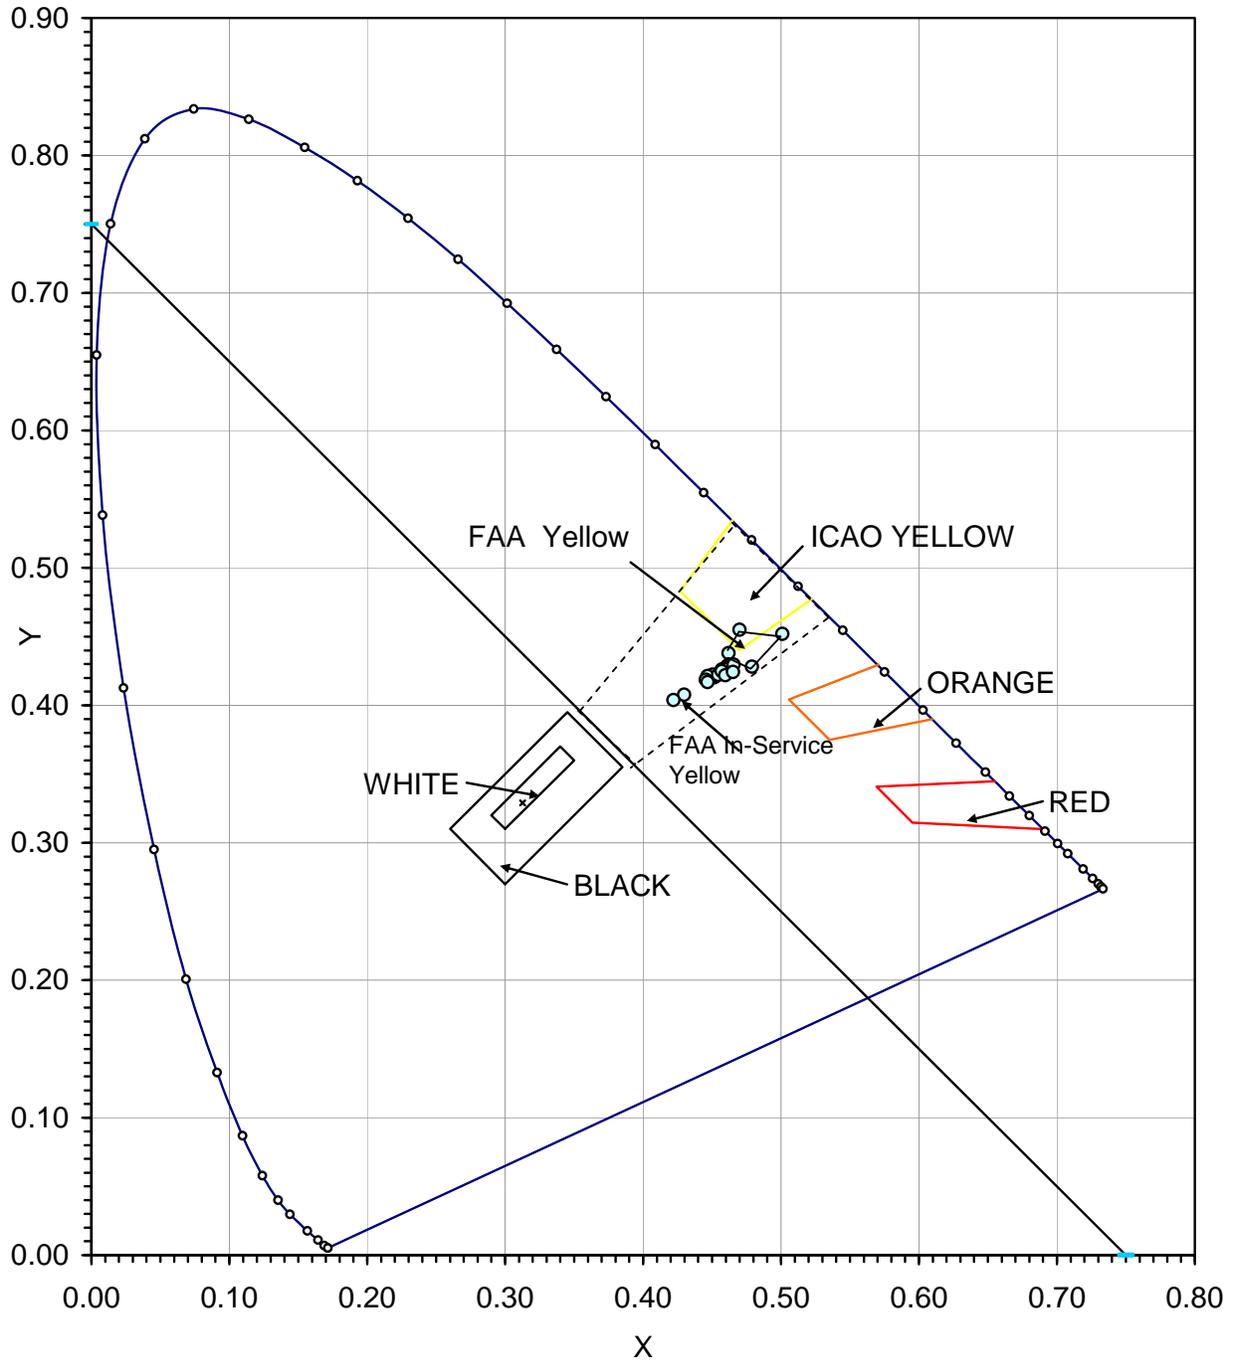
Figure A-43. Chromaticity Readings of CCRHPS, Yellow Thermoplastic Solid Line at EWR

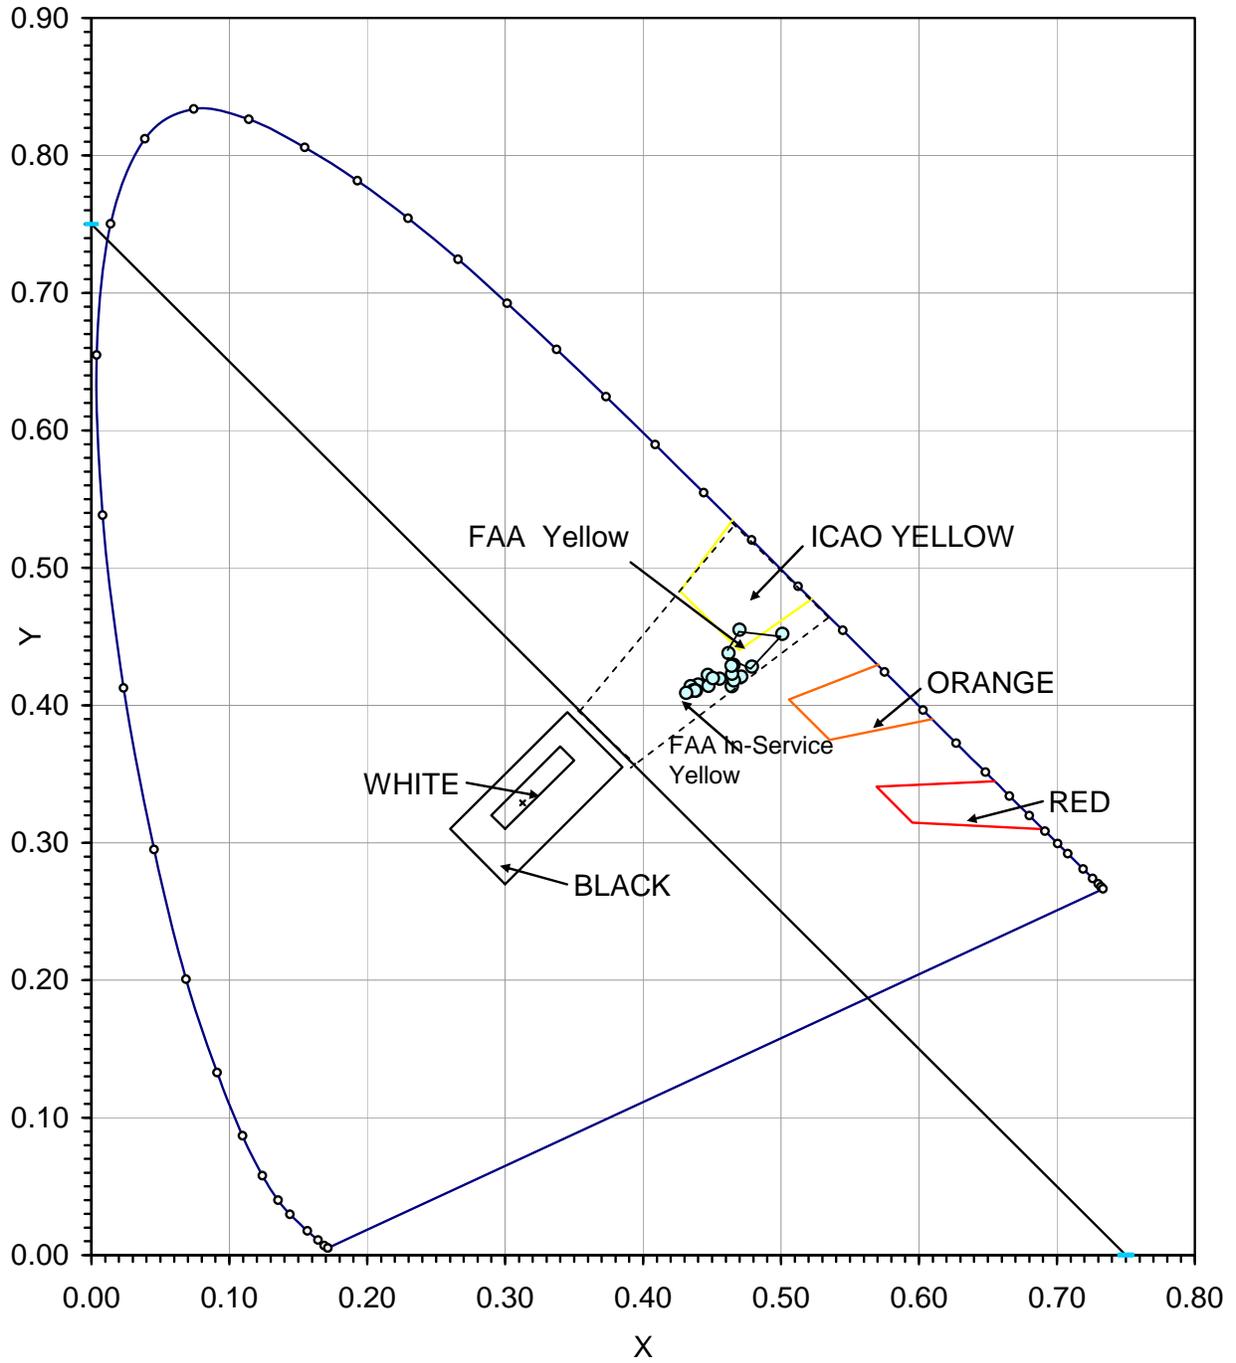
Figure A-44. Chromaticity Readings of CCRHPD, Yellow Thermoplastic Dash Line at EWR

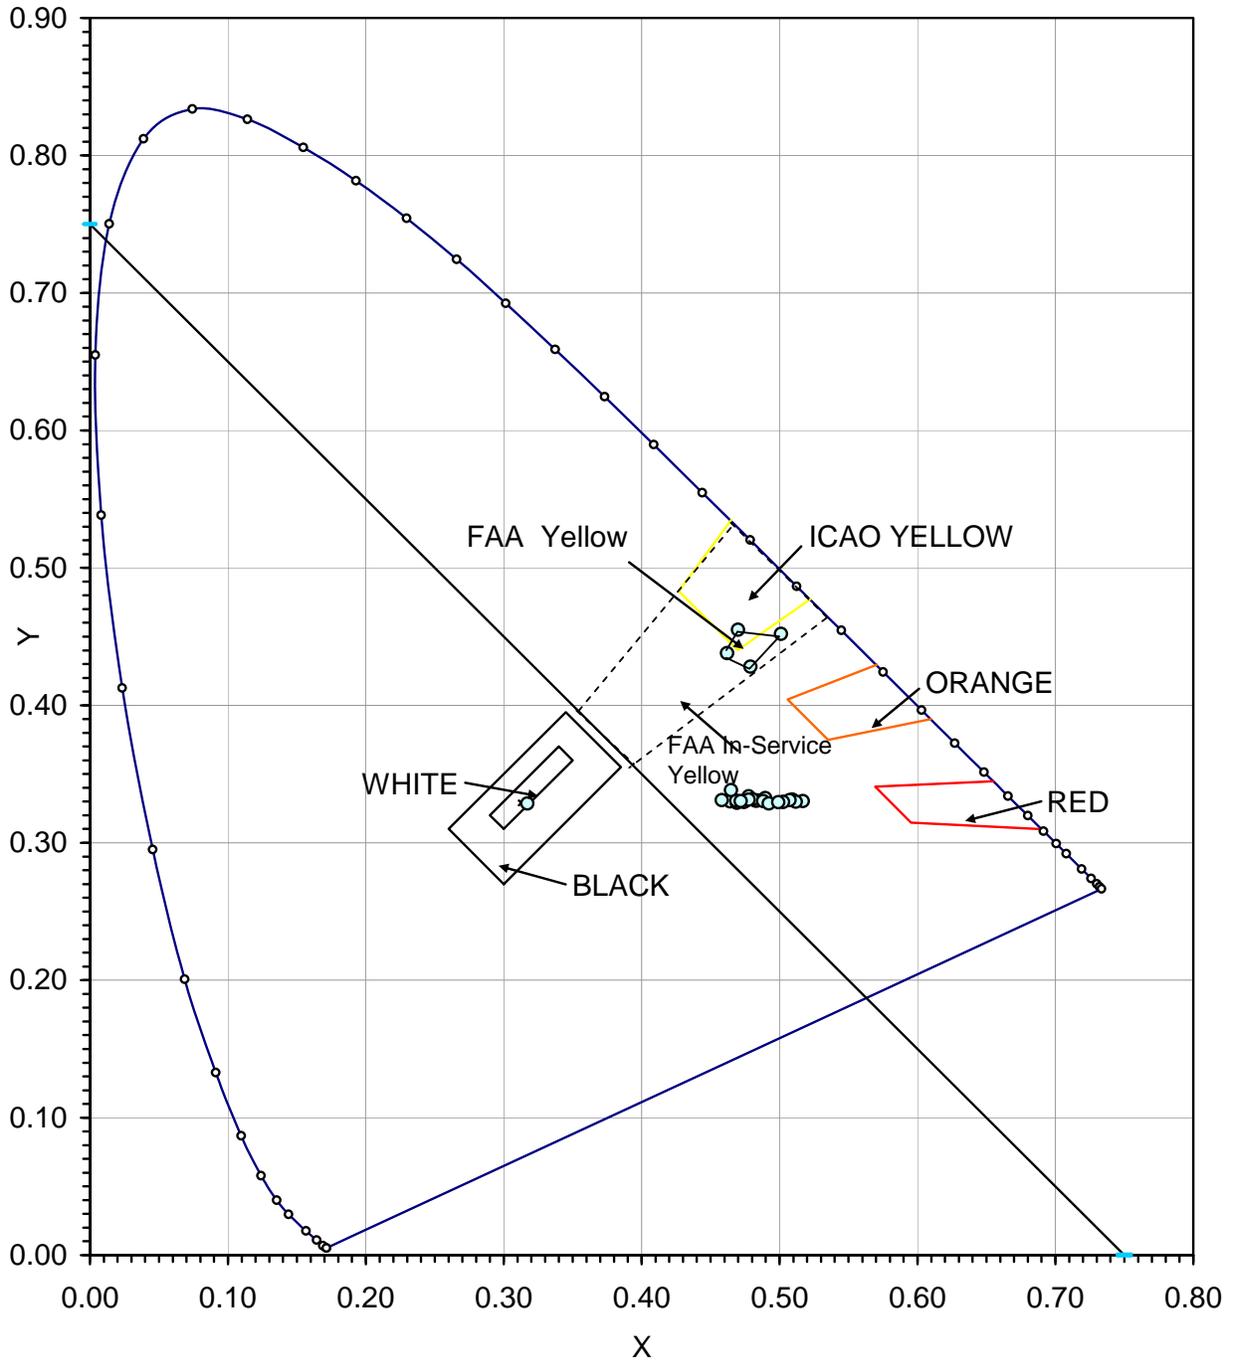
Figure A-45. Chromaticity Readings of CCRID, Red Thermoplastic at EWR

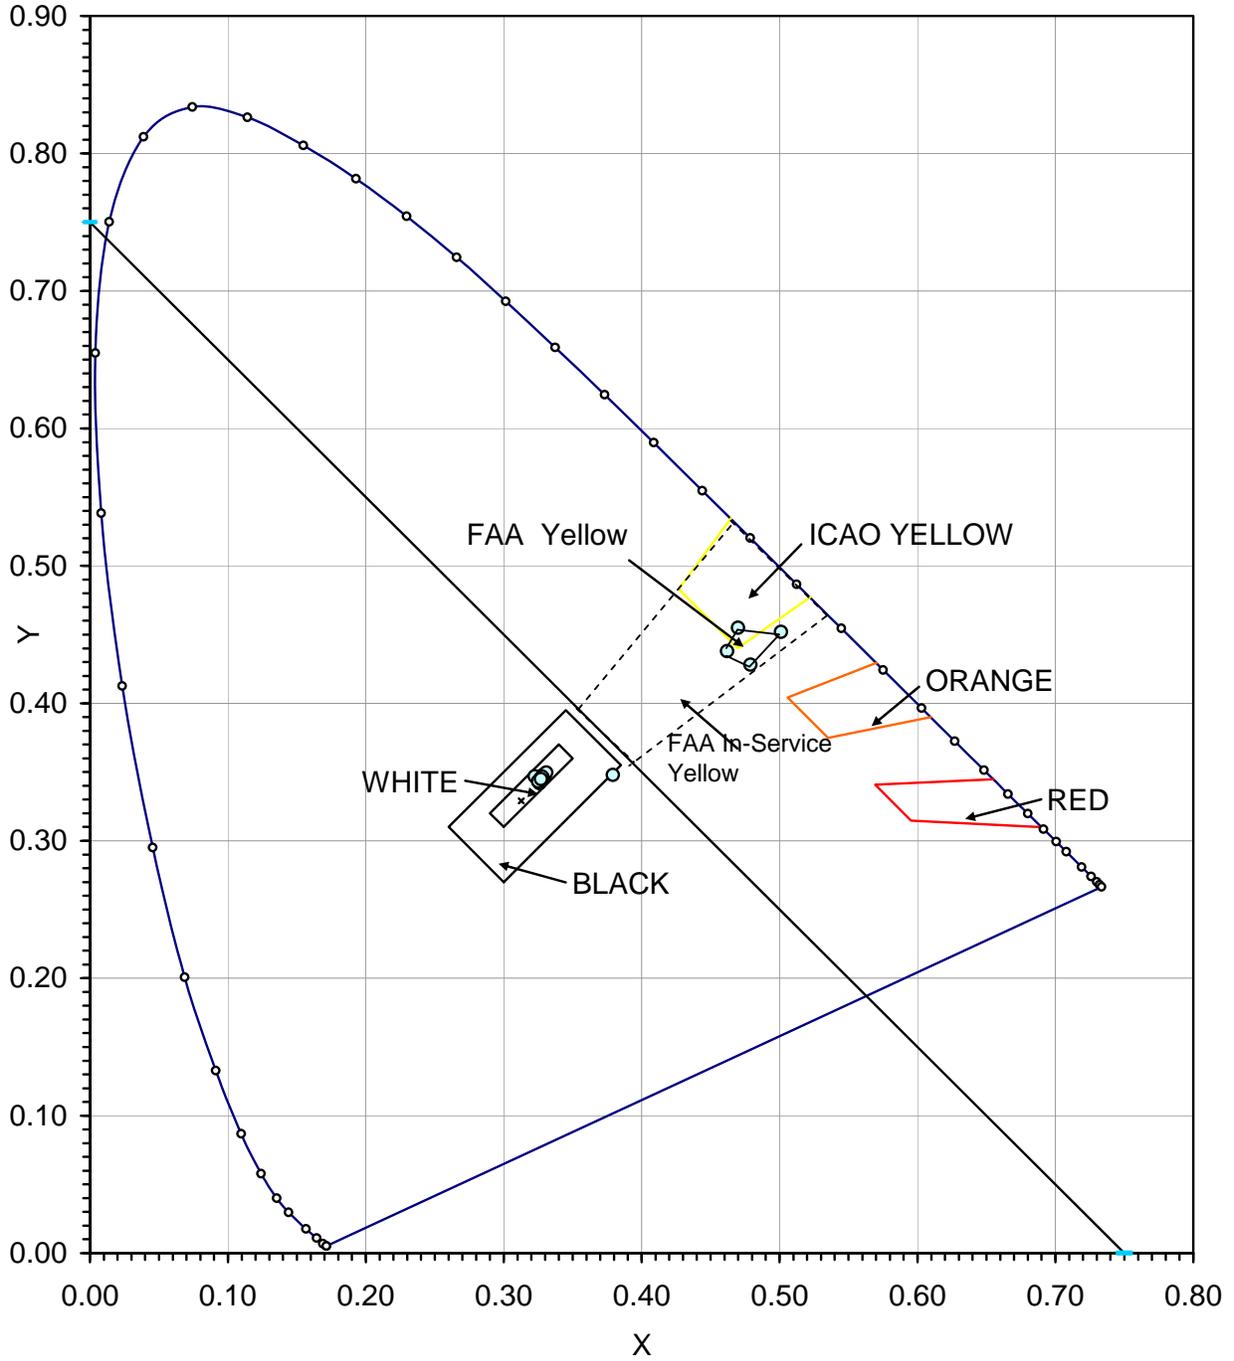
Figure A-46. Chromaticity Readings of CCRID, White Thermoplastic at EWR

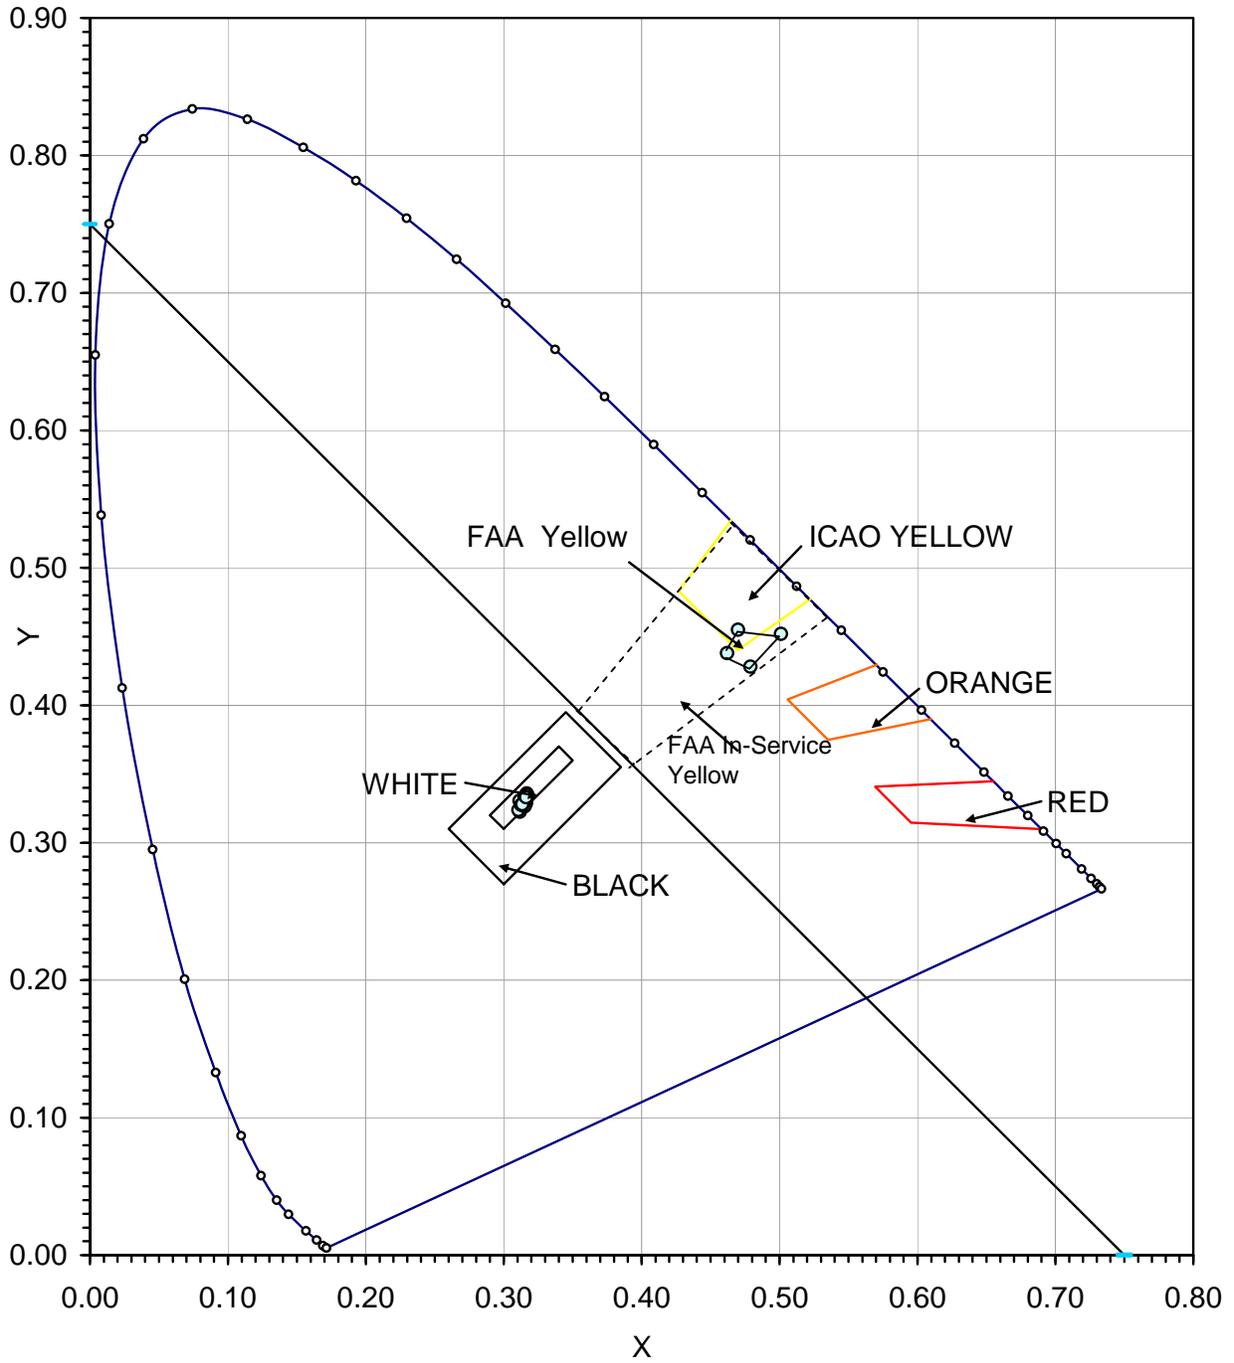
Figure A-47. Chromaticity Readings of CCRID, Black Thermoplastic at EWR
